**PERFORMANCE EVALUATION OF THE CARTER ARCHITECTURAL PANELS INC.,
“EVO™ RIVETLESS™ PANEL SYSTEM”
IN ACCORDANCE WITH AAMA 508-07 FOR PRESSURE EQUALIZATION
BEHAVIOR & WATER PENETRATION RESISTANCE**

16-06-M0171-2DR
7 Pages, 3 Appendices

July 7, 2016

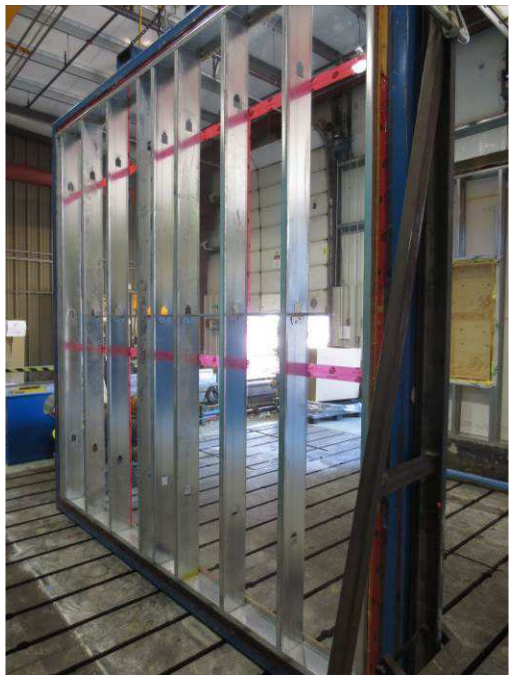
Figure B1 – Backup Wall Framing and Plexiglas Installation

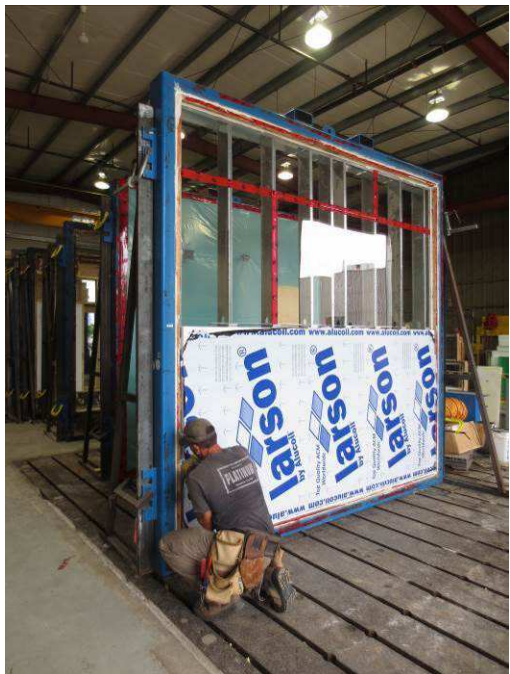
Figure B2 – Lower Panel Installation

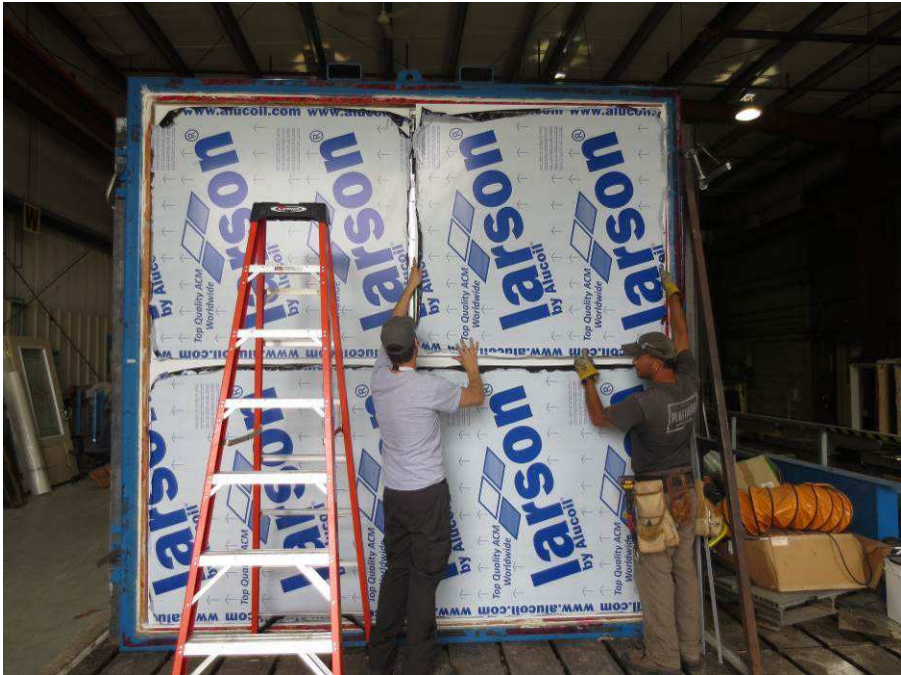
Figure B3 – Upper Panel Installation

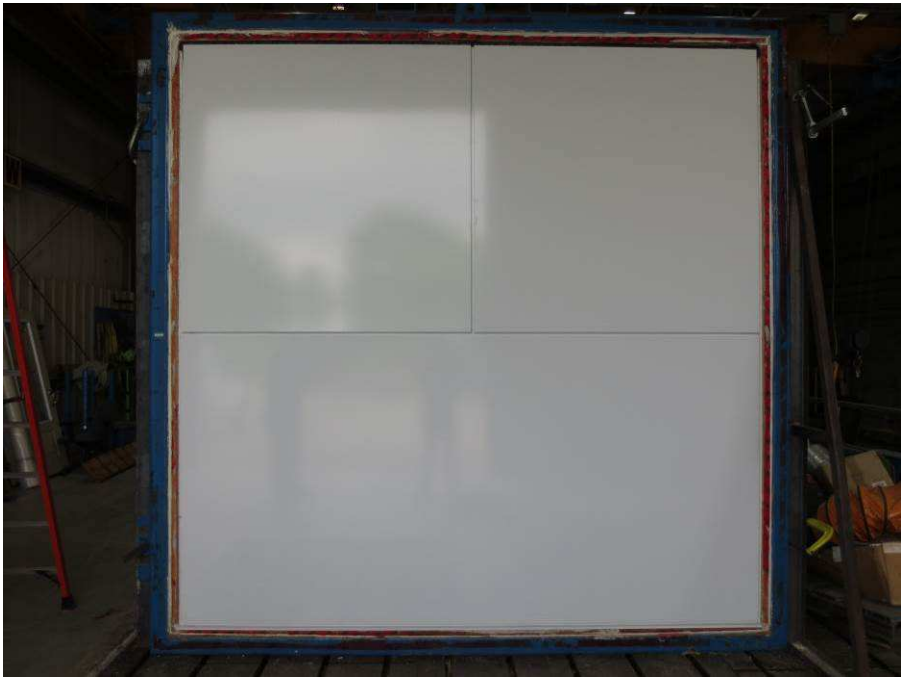
Figure B4 – Completed Wall

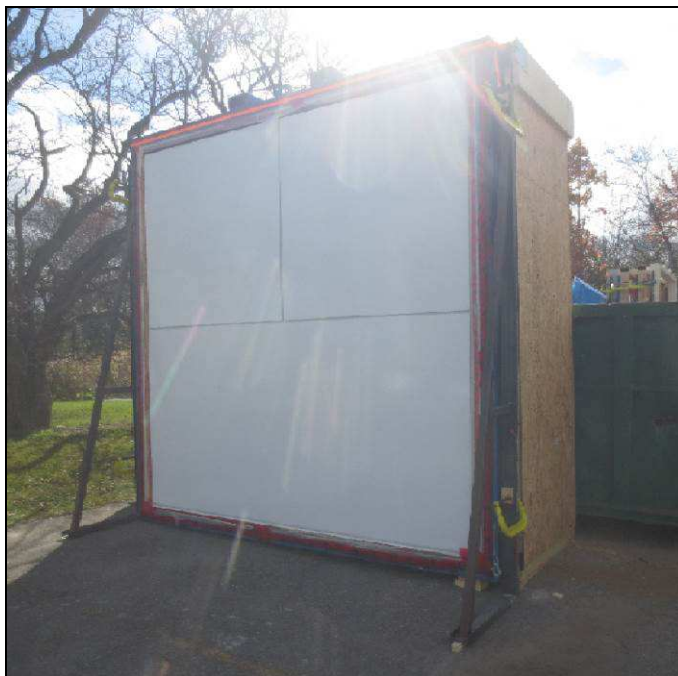
Figure C1 - Specimen Set up in front of viewing chamber

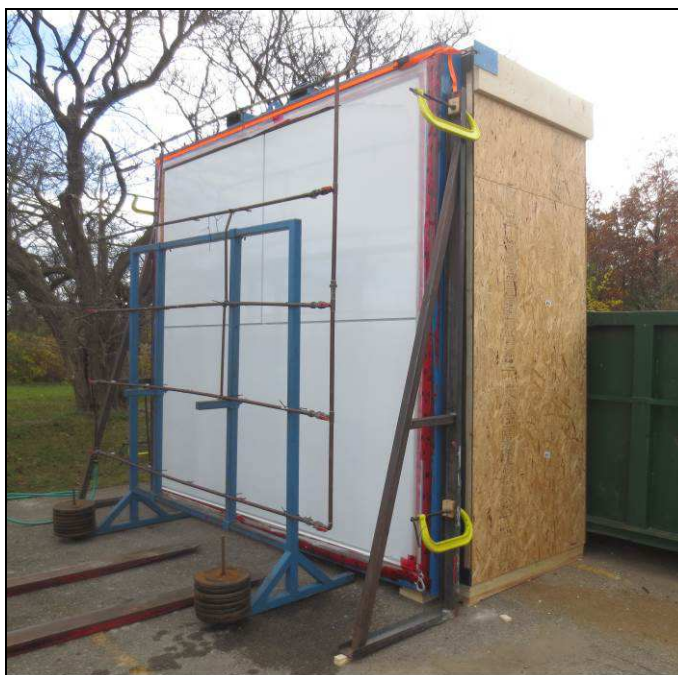
Figure C2 - Spray rack Set up for water penetration

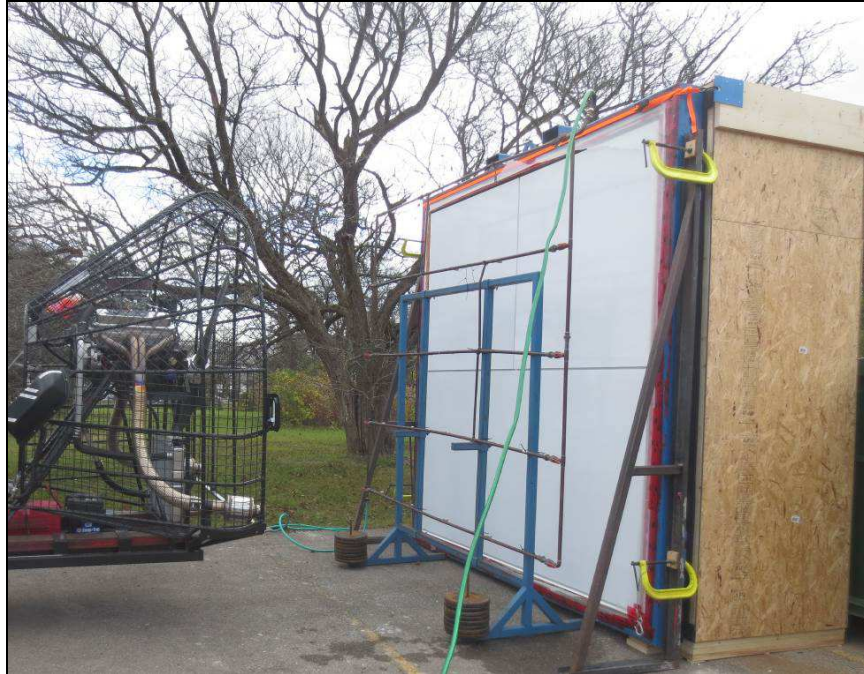
Figure C3 - Wind Machine setup to simulate Dynamic Pressure (AAMA 501.1-05)
